Challenge:

Acoustic Logging Result:

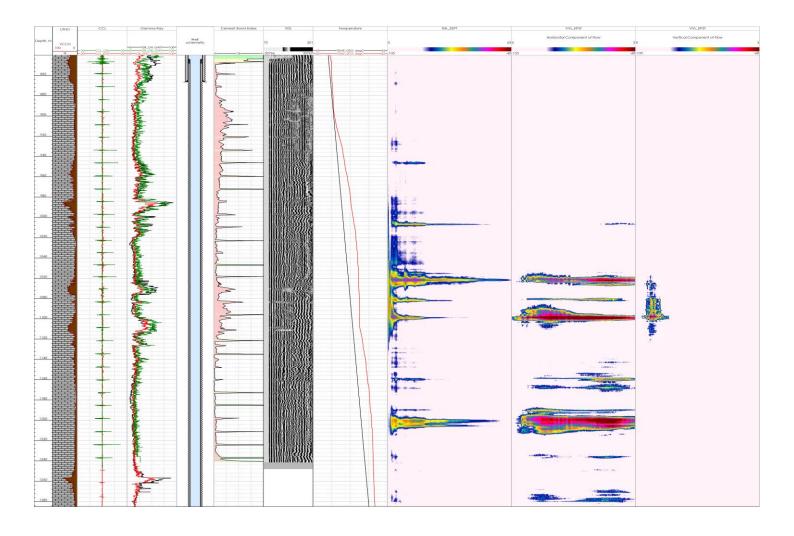
The recorded SNL data and the horizontal component of flow from the VVL log indicated fluid movement from 980 -1280 m. This revealed the presence of a few narrow intervals with greater noise amplitude which, in all probability, could be associated with existence of a naturally fractured formation and lateral fluid movement.

The vertical component of flow from the VVL log together with the temperature curve indicated the presence of crossflow from 1044-1103 m. The CBL-VDL log run from 850-1240 m (top of the 7" liner) indicated poor cement quality across the entire logged interval with a very low cement bond index. This could be attributed to the CBL being run after 24 hours from cement placement instead of the recommended 72 hours to allow the cement to fully set.

However, the SNL+VVL were run 14 days after the cement job and the acoustic data had a good correlation with the cement bond index. The CBL showed a greater bond index at 850 -980 m and the SNL+VVL did not indicate crossflow behind the liner. Intervals with well-marked noise have the lowest cement bond index.
