Integrity Challenge:

Corrosion Logging Result:

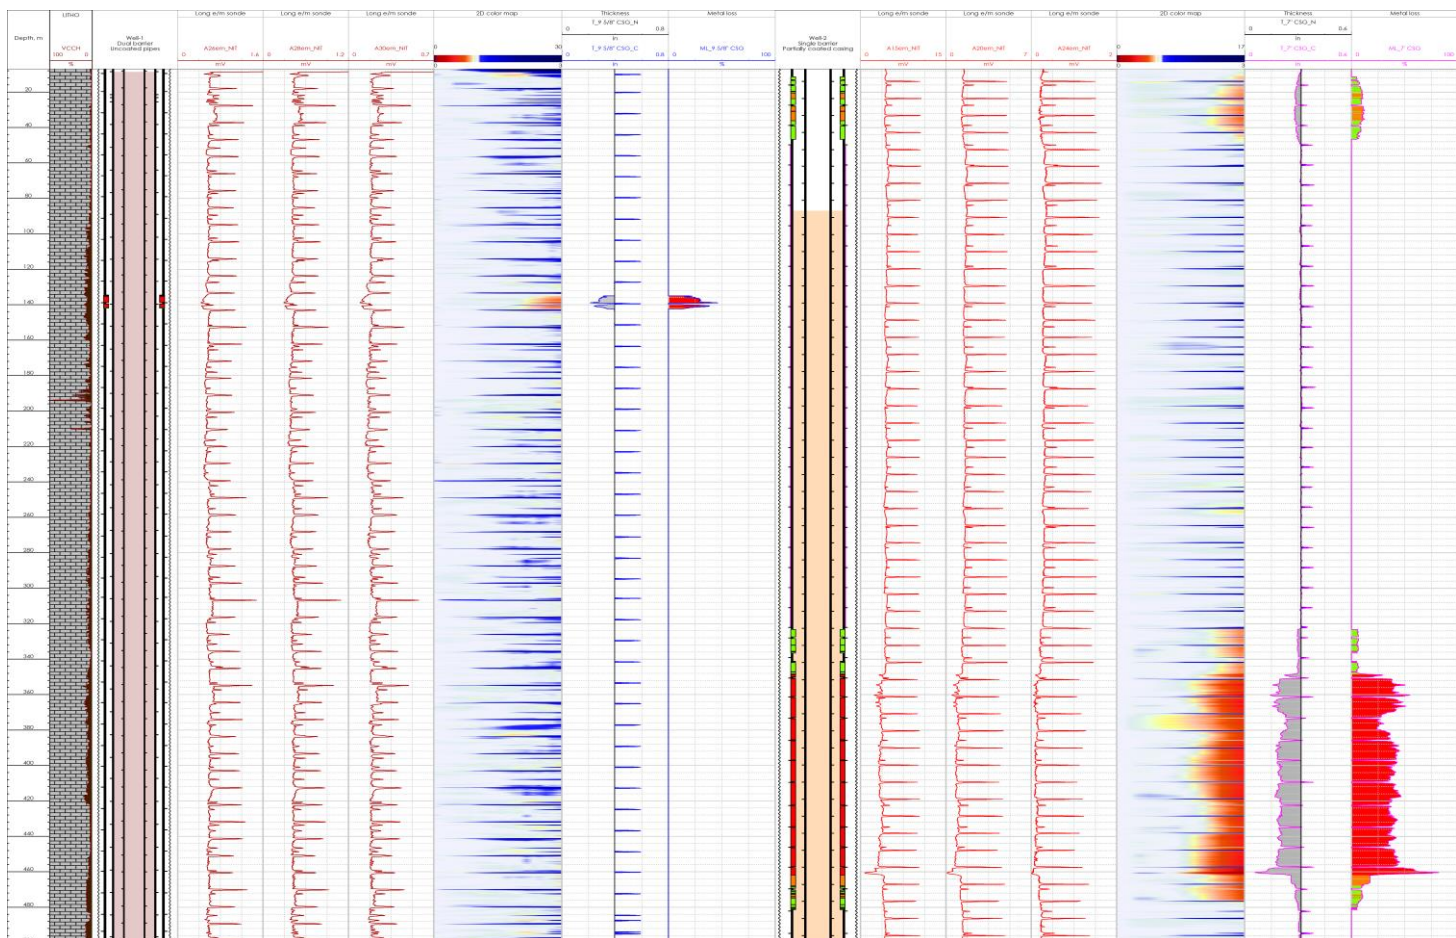
One example of sub optimal external coating on the outer casing is shown below:

A dual barrier oil producer is presented on the left side in the snapshot shown below. The well was drilled and completed in 1995 with a 9 5/8" surface casing and a 7" production casing. EMDs corrosion logging was conducted in 2013. The data indicated severe corrosion in the 9 5/8" casing at 133-143 m. In the 17 years since drilling the maximum metal loss had reached almost 50%. The results are similar in other wells with the same completion design: metal loss on the surface casing was evident at an interval 130-240 m with differing levels of severity.

A single barrier oil producer is presented on the right side in the snapshot below. The well was drilled in 2015 and was completed with a single 7" casing with external coating from 50- 324 m, the remainder of the string was uncoated. EMDs corrosion logging was conducted in 2020, 5 years after the well was completed with the main objective to check the integrity status of the well and the efficiency of the external coating. Corrosion data indicated that the 7" casing has 2 extended intervals of corrosion above and below the coated area. The upper interval 11-45 m with maximum metal loss of 15%, the lower interval 324-484 m with maximum metal loss of 80%. There is a possible through wall defect at 460 m. It appeared that due to the potential difference between coated and uncoated areas, corrosion migrated above and below the coated area.

The well was immediately included in the remedial operational plan and a month later the well was worked over. A retrievable bridge plug (RBP) was run to 550 m and the pressure test of the 7" casing failed. A 5.5" scab liner was run from surface to 700 m. Despite running the partially externally coated casing string the life of the well was only 5 years until there was a well integrity failure.

This example clearly demonstrates that the interval of coated pipe should not be placed just across the interval of expected corrosion. All the uncemented i.e. exposed pipe should be coated. This will minimize the effects of corrosion.
