**Integrity Challenge:**

**Corrosion Logging Result:**

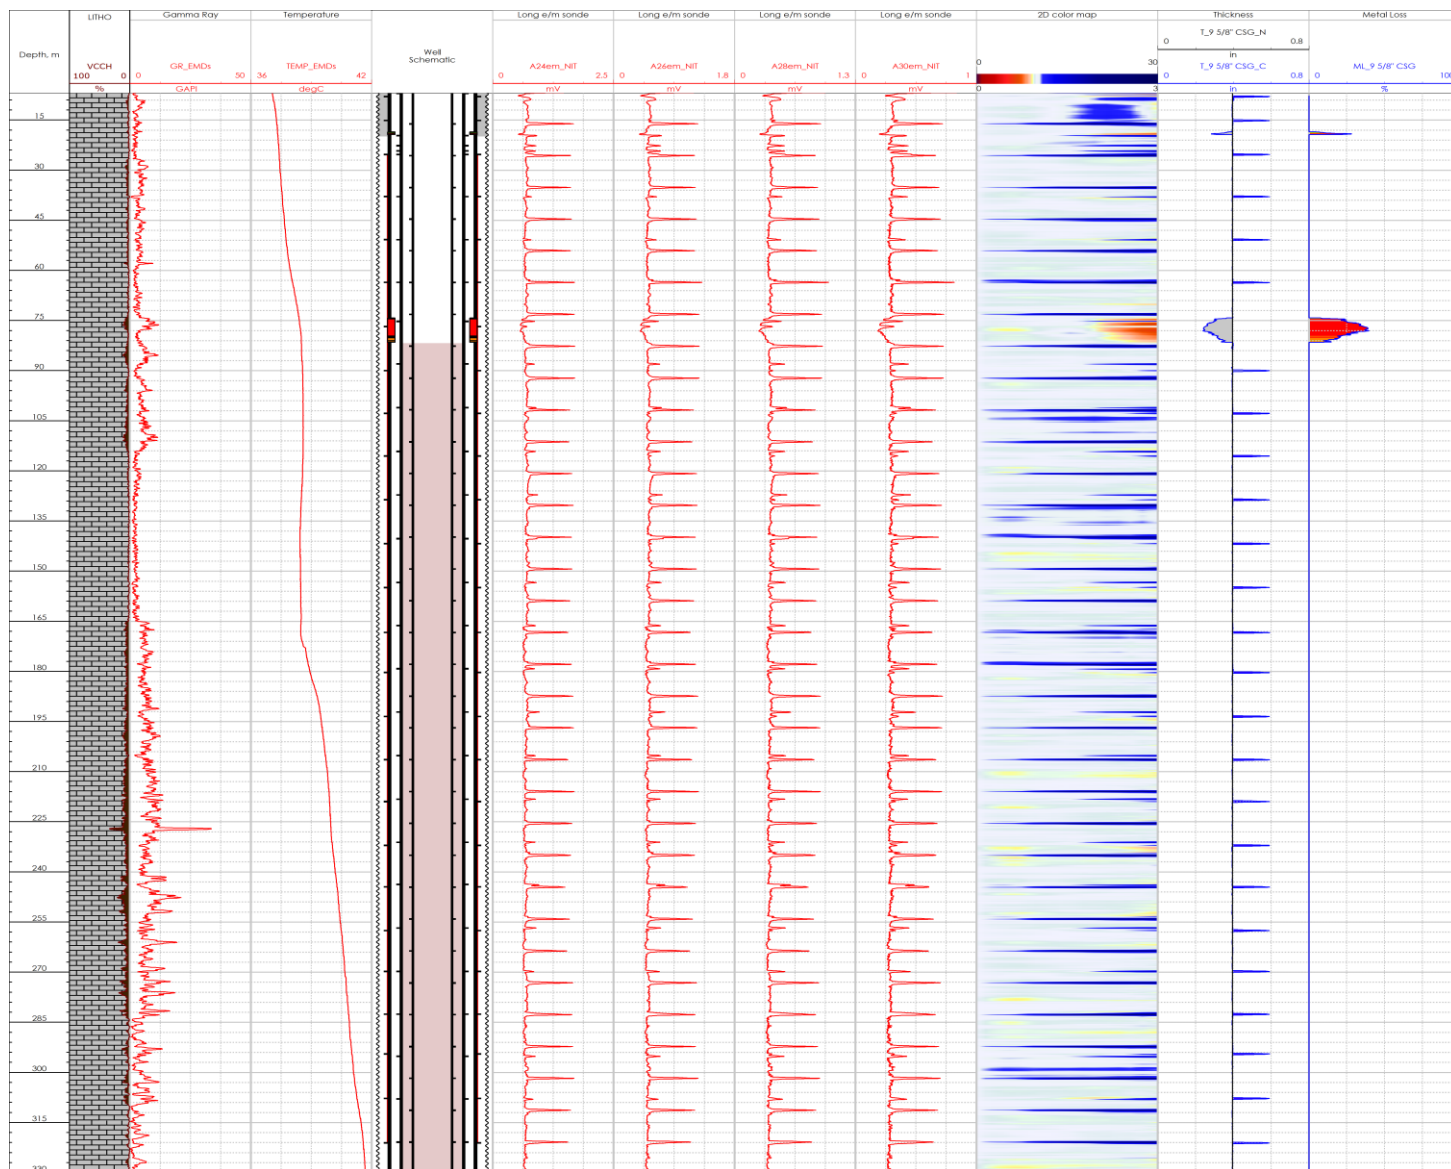
One example of sub optimal external coating on the outer casing is shown below:  
 The well is a vertical bean pump (BP) oil producer drilled in 2009. The well was completed with a 9 5/8" surface casing and a 7" production liner. The 9 5/8" casing has external coating from 24-322 m. A 4.5" BP completion string was run.  
 In 2017 the well was worked over. The completion string was pulled and a retrievable bridge plug (RBP) set at 805 m. The 9 5/8" casing was pressure tested and failed. A 7" scab liner was installed from surface to the top of the 7" production liner. A BP completion string was run and the well put on production.  
 In 2022 EMDs corrosion logging was conducted as part of an integrity monitoring program.  
 Corrosion logging data indicated that the 9 5/8" surface casing had two intervals of severe corrosion. The first interval is a very narrow interval at 19 m, this is 5 m above the externally coated casing. The shape of the recorded curves indicated the possibly of a through wall defect at this depth. The second interval from 74-82 m is located across an externally coated area. It is known that that 1 m from both ends of the pipe the connections are not coated. This is to allow space for the pipe slips and make-up tongs to clamp directly on to the pipe during connection make up. These areas are effectively weak points in the corrosion protection. The data showed that corrosion initiated at the casing collar with a maximum metal loss of 40%. In all probability, these two intervals are the main cause of the failed casing pressure test.

Coating pipe is effective at minimizing corrosion on the pipe body. However, the uncoated areas and couplings are still vulnerable to corrosion. It is therefore recommended that corrosion monitoring is carried out on a regular basis.
