Integrity Challenge:

Corrosion Logging Result:

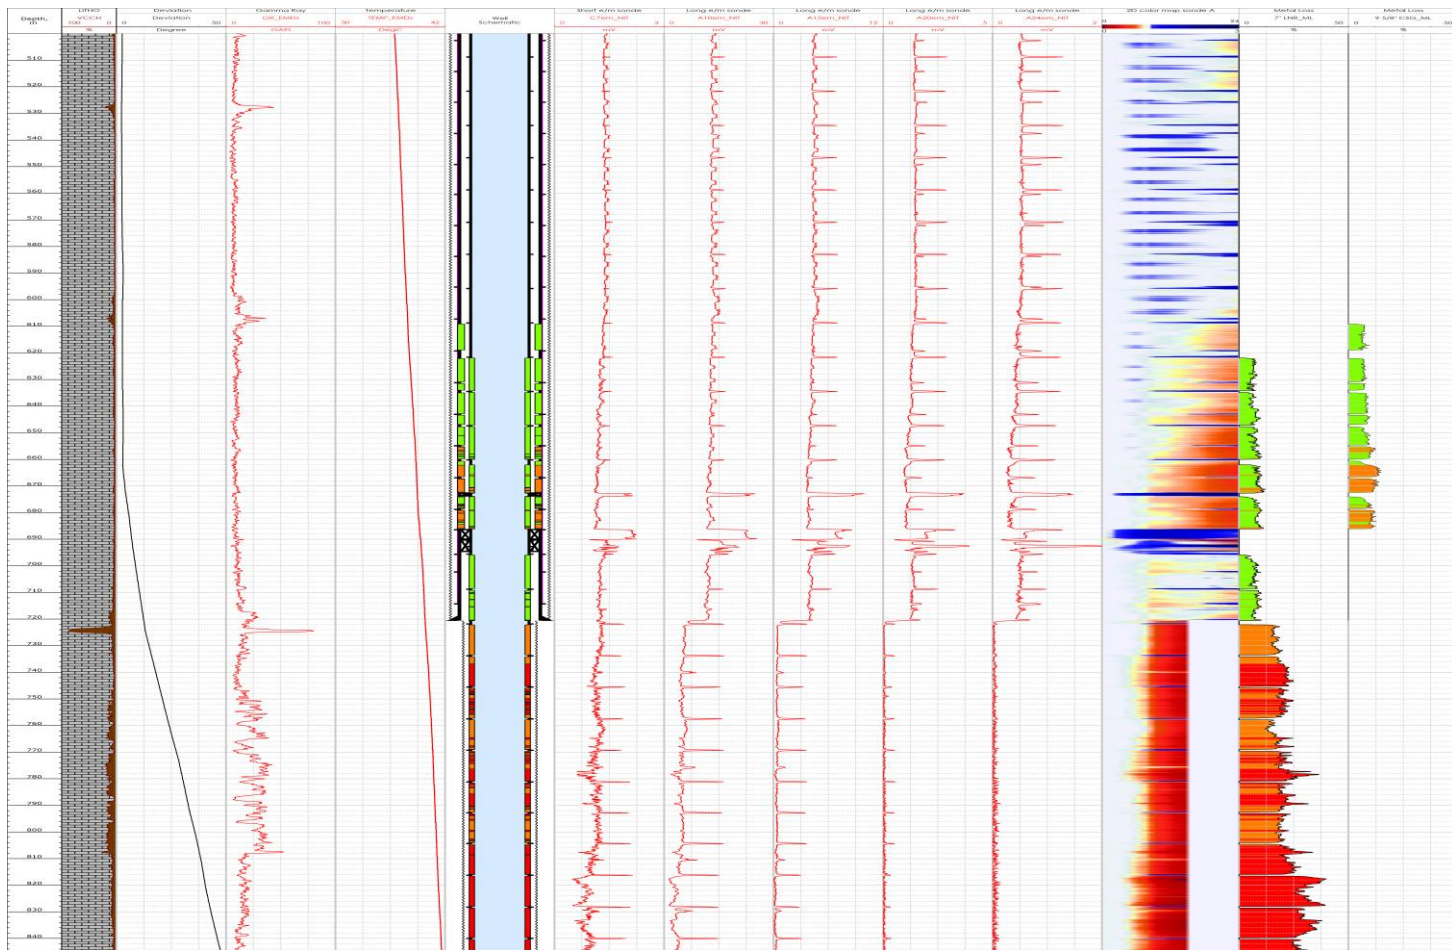
One example of sub optimal external coating on the outer casing is shown below:

In 2023 due to a pump failure a Hoist attended the well. The completion string was pulled and a RBP was run in the hole to 760 m to pressure test the scab liner. However, a number of attempts to set the RBP failed. The RBP was pulled to surface and a corrosion log was recorded from 845 m to surface. The log data revealed the presence of severe, moderate and minor metal loss in the 7" intermediate liner. In addition, there was an extended interval of minor corrosion in the 7" scab liner from 620-685 m. Furthermore, an extended interval of moderate and minor corrosion was detected internally in the 9 5/8" casing from 608-720 m (casing shoe) across the externally coated area. It appeared that corrosion initiated across the deviated section of the 7" intermediate liner and moved upwards to the liner hanger. Corrosion then migrated to the internal surface of the 9 5/8" casing. When the well had a scab liner installed the corrosion moved up from the intermediate liner to the scab liner.

It is evident from the log data that the corrosion in this well was very aggressive. The external coating on the 9 5/8" casing protected the external wall of the casing from the corrosive aquifer. However internal corrosion existed due to contact with corrosive fluids in the internal surface of the pipe.

External coating is effective in mitigating corrosion on the coated areas of the pipe. It does not provide protection to the uncoated areas of the pipe or the internal surface of the pipe. Consideration should also be given in future well designs to incorporate coating on the internal surface of the pipe to minimize corrosion.
