Field Overview:

EMDs Overview:

Metal Loss Analysis:

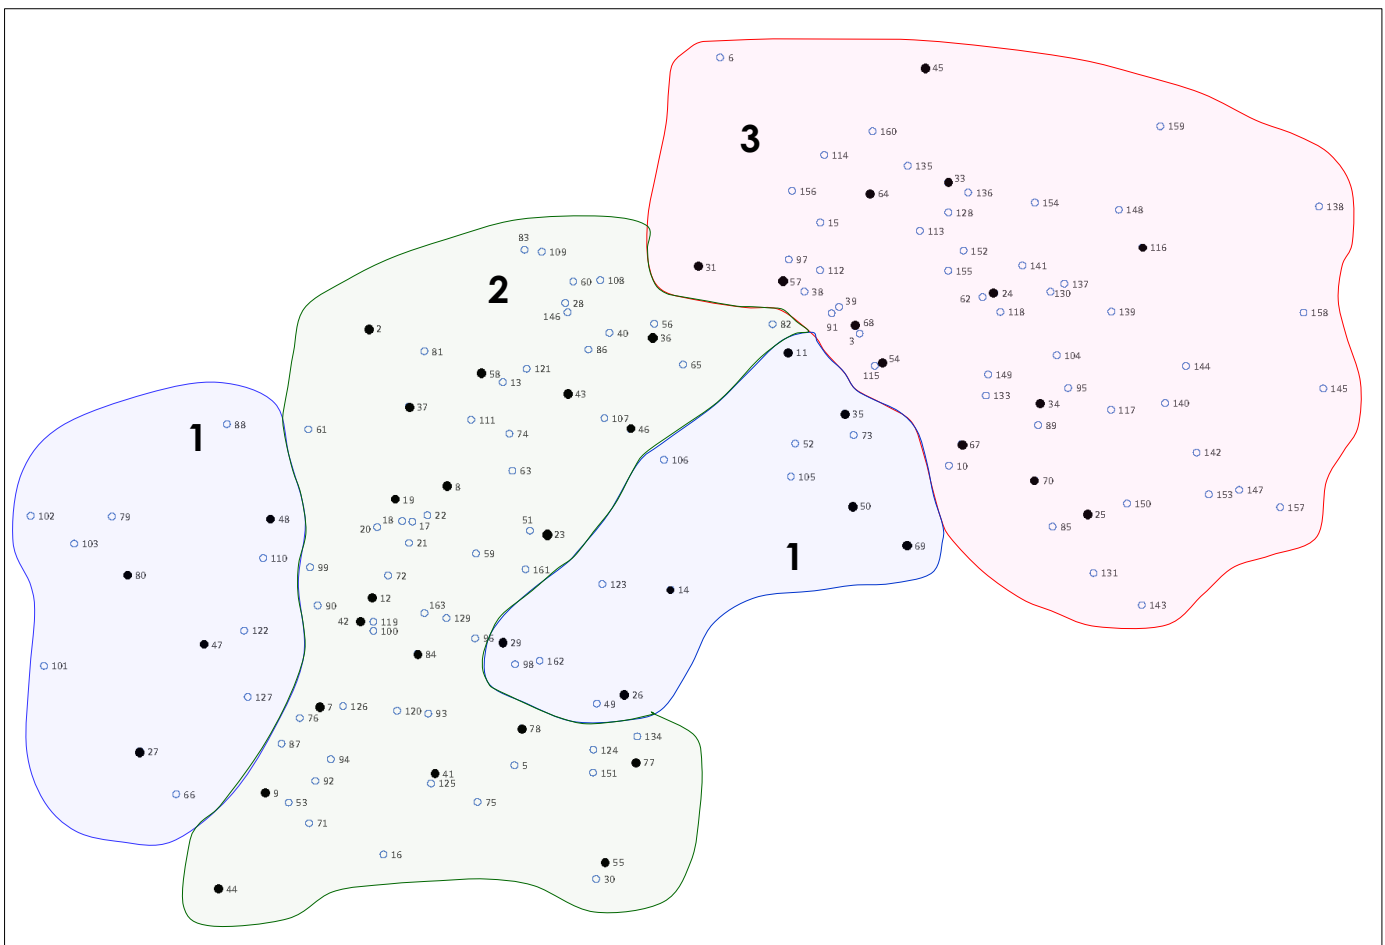
Metal loss after 15 years from well completion

Based on the corrosion trend the wells can be divided into three groups where each group had a similar trend in the rate of corrosion in the 13-3/8" casing.

When detailed analysis was completed, the following common patterns were discovered:

- The metal loss trend in Group 1 is linear where corrosion was initiated immediately from the well completion date. The average metal loss per year was 2-3% reaching 40-45% after 15 years.
- The metal loss trend in Group 2 was exponential. Metal loss was initiated 3 years from the completion date on average and reached up to 45% after 15 years.
- The metal loss trend in Group 3 is almost linear where corrosion initiated from the well completion date. Metal loss reached almost 100% after 15 years.

Based on the analysis above, the following recommendations were provided to the client:

1. To clarify the boundaries between Groups 1, 2 and 3, wells which were drilled 7-8 years ago should be scheduled for corrosion logging.
2. High priority should be given to all wells in Group 3.

3. As a proactive measure, install a 7" scab liner in Well-31 and Well-33.
4. Repeat corrosion logging in Well-34 which is included in Group 3. Note EMDS logging was conducted 5 years from the well completion date which was in 2013, the current predicted metal loss in the surface casing is approximately 100%.

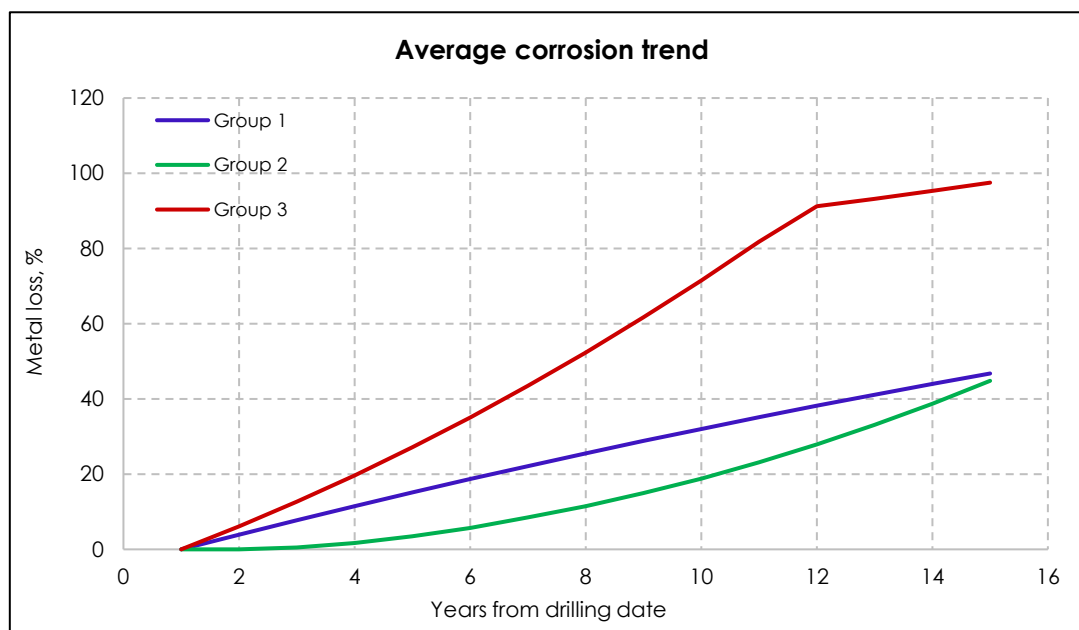
The plot below shows the average corrosion rate of each group.
