Integrity Challenge:

Corrosion Logging Result:

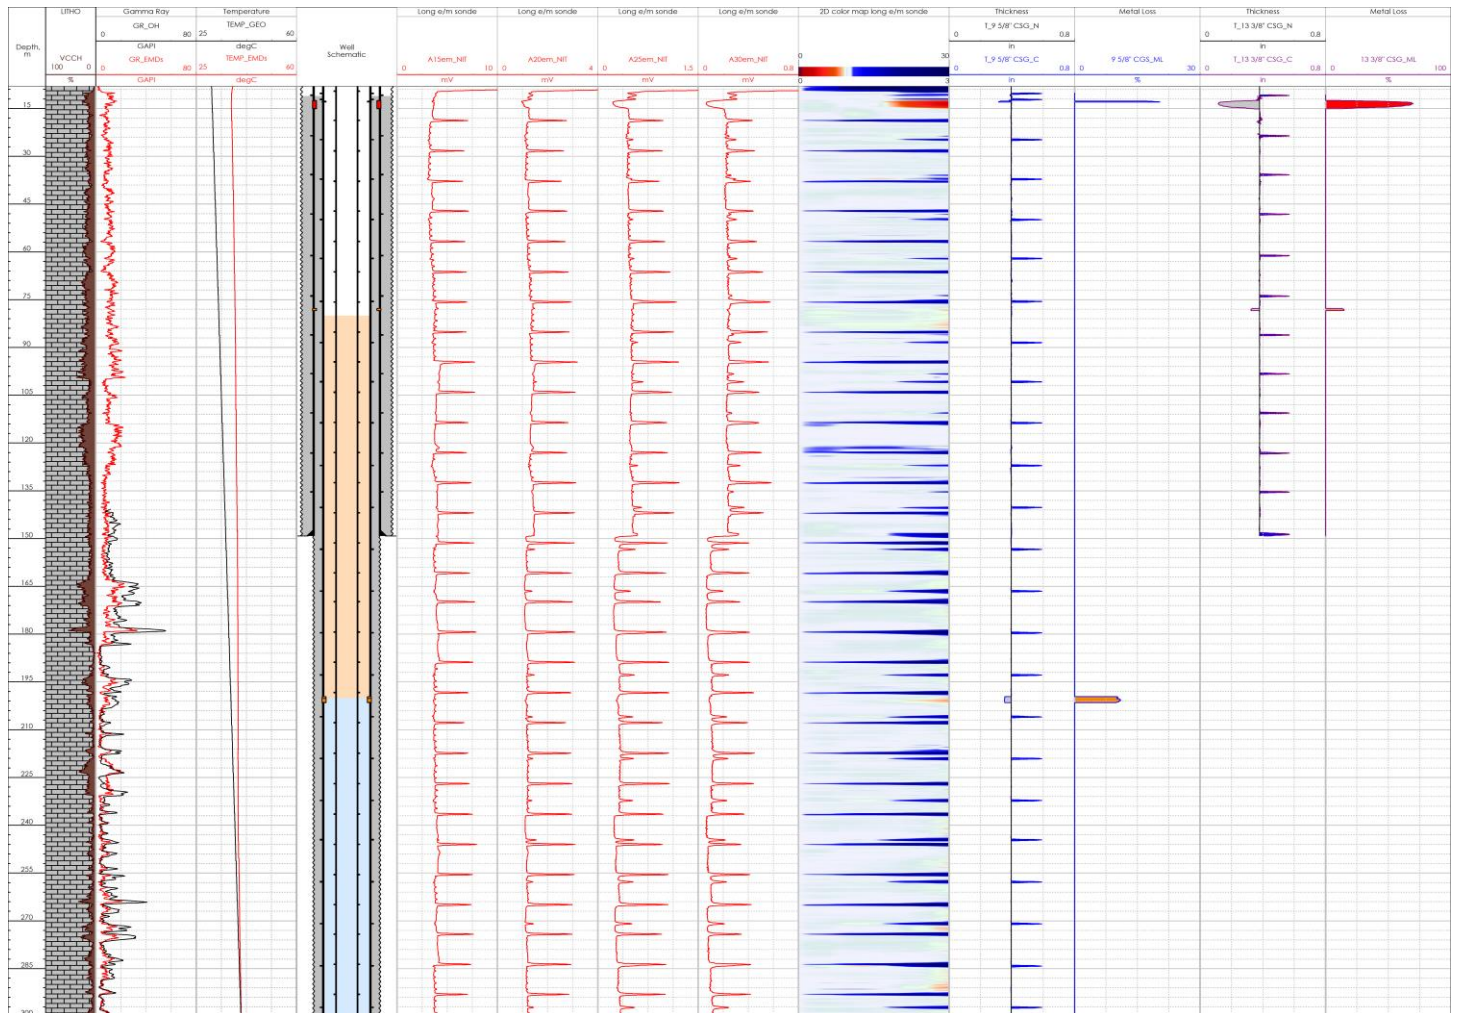
One example when corrosion logging was conducted and multi barrier metal loss on the outer casing and inner casing was detected is shown below:

In September 2019 a subsurface integrity test (SIT) was conducted and the B annulus leak-off test (LOT) failed.

In September 2021 an EMDs corrosion log was conducted. The EMDs log data indicated the presence of two corroded intervals in the 13 3/8" casing. The first is at a shallow section of the well where the average metal loss was almost 70%. In all probability the severe metal loss in the casing is the root cause of the LOT failure. The second area is a localized interval with metal loss less than 20%. The 9 5/8" casing had two intervals of metal loss. The first one in the shallow section of the well where the corrosion from the 13 3/8" casing and migrated to the inner 9 5/8" casing. The average metal loss across this interval was 20%. The second corroded interval was in the 9 5/8" casing located below the 13 3/8" casing shoe where the 9 5/8" casing is the only barrier; the metal loss was less than 20%. Based on the corrosion log data it was decided to run a 7" scab liner to eliminate a possible leak to surface.
