### Corrosion Logging Result:

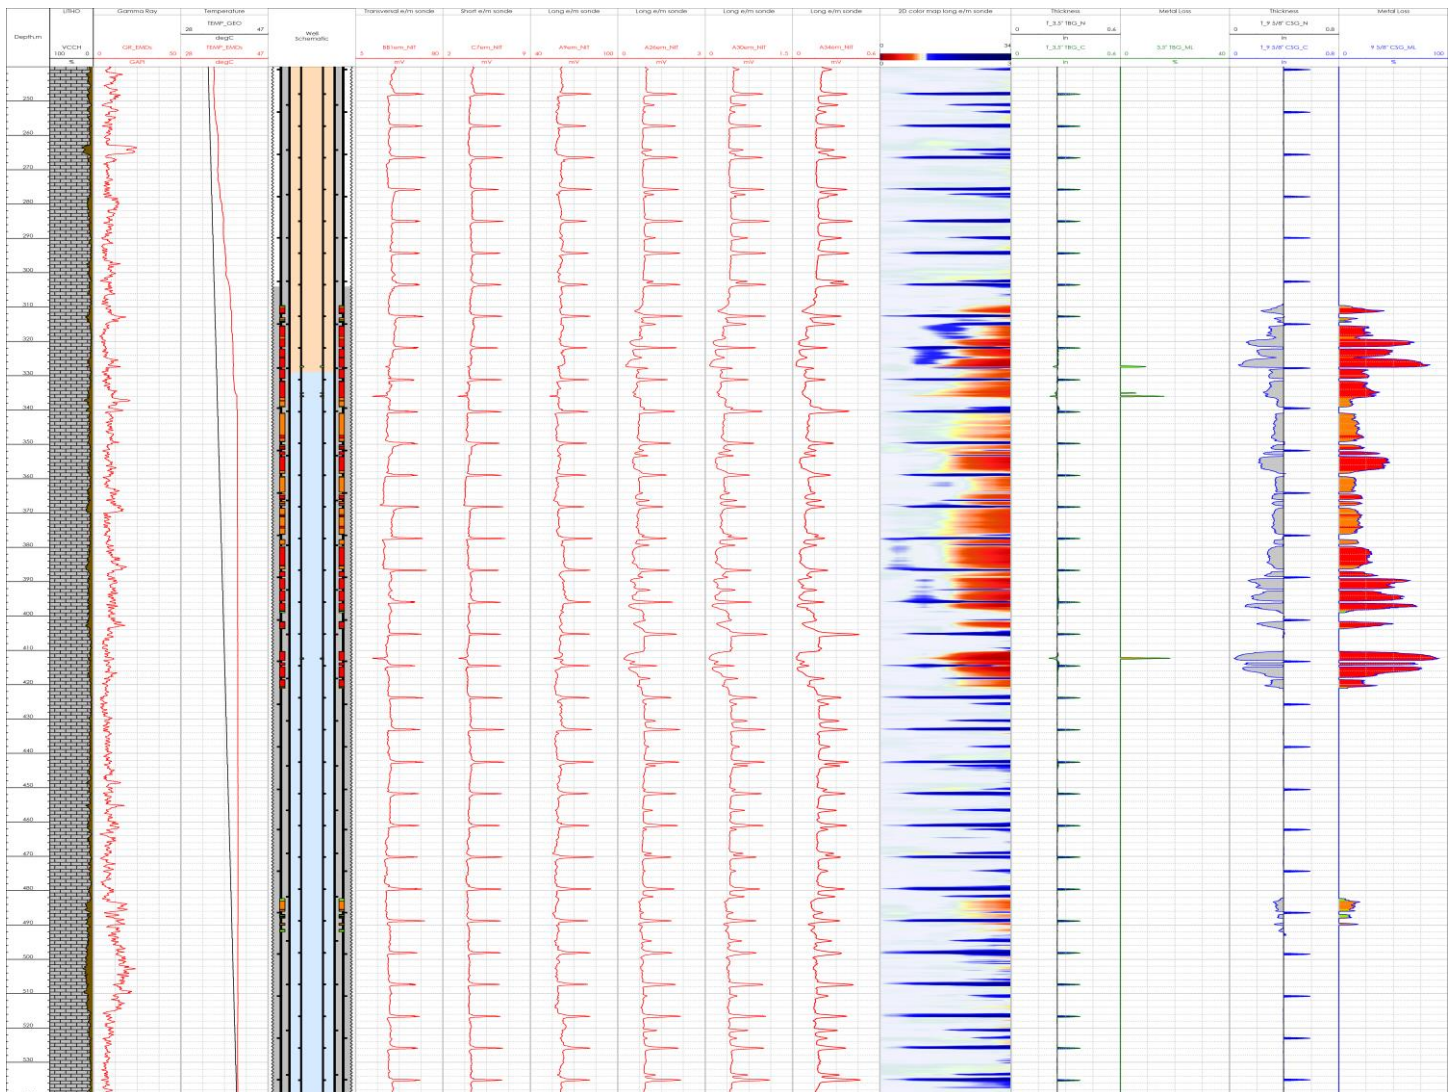
The EMDs log data indicated that the 9 5/8" surface casing had an extended corroded interval with a maximum metal loss of 95%. The corroded interval was located across cemented casing and started from the TOC. It is probable that the cement is of poor quality and the TOC is deeper than predicted.

In addition to surface casing corrosion, 3 intervals of localized metal loss were detected in the completion string. This was evident from the clear response from the transversal and short e/m sondes which log the first barrier only with high resolution. The shape of the recorded curves indicated the presence of through wall defects i.e., holes. In all probability these holes allowed produced fluid circulation into the annulus and possibly causing the decline in production. The temperature curve confirmed the interpretation as it showed crossflow from 336 m where holes in the tubing had been identified.

Based on the corrosion log result the well was worked over and returned to production. In addition, it was recommended to include the well in a corrosion monitoring plan as the corrosion rate was aggressive. In only 7 years the corrosion rate had reached almost 100% in the surface casing. There is also uncertainty with the quality of the cement behind production casing which could lead to corrosion migration to the production casing.
