Integrity Challenge:

Corrosion Logging Result:

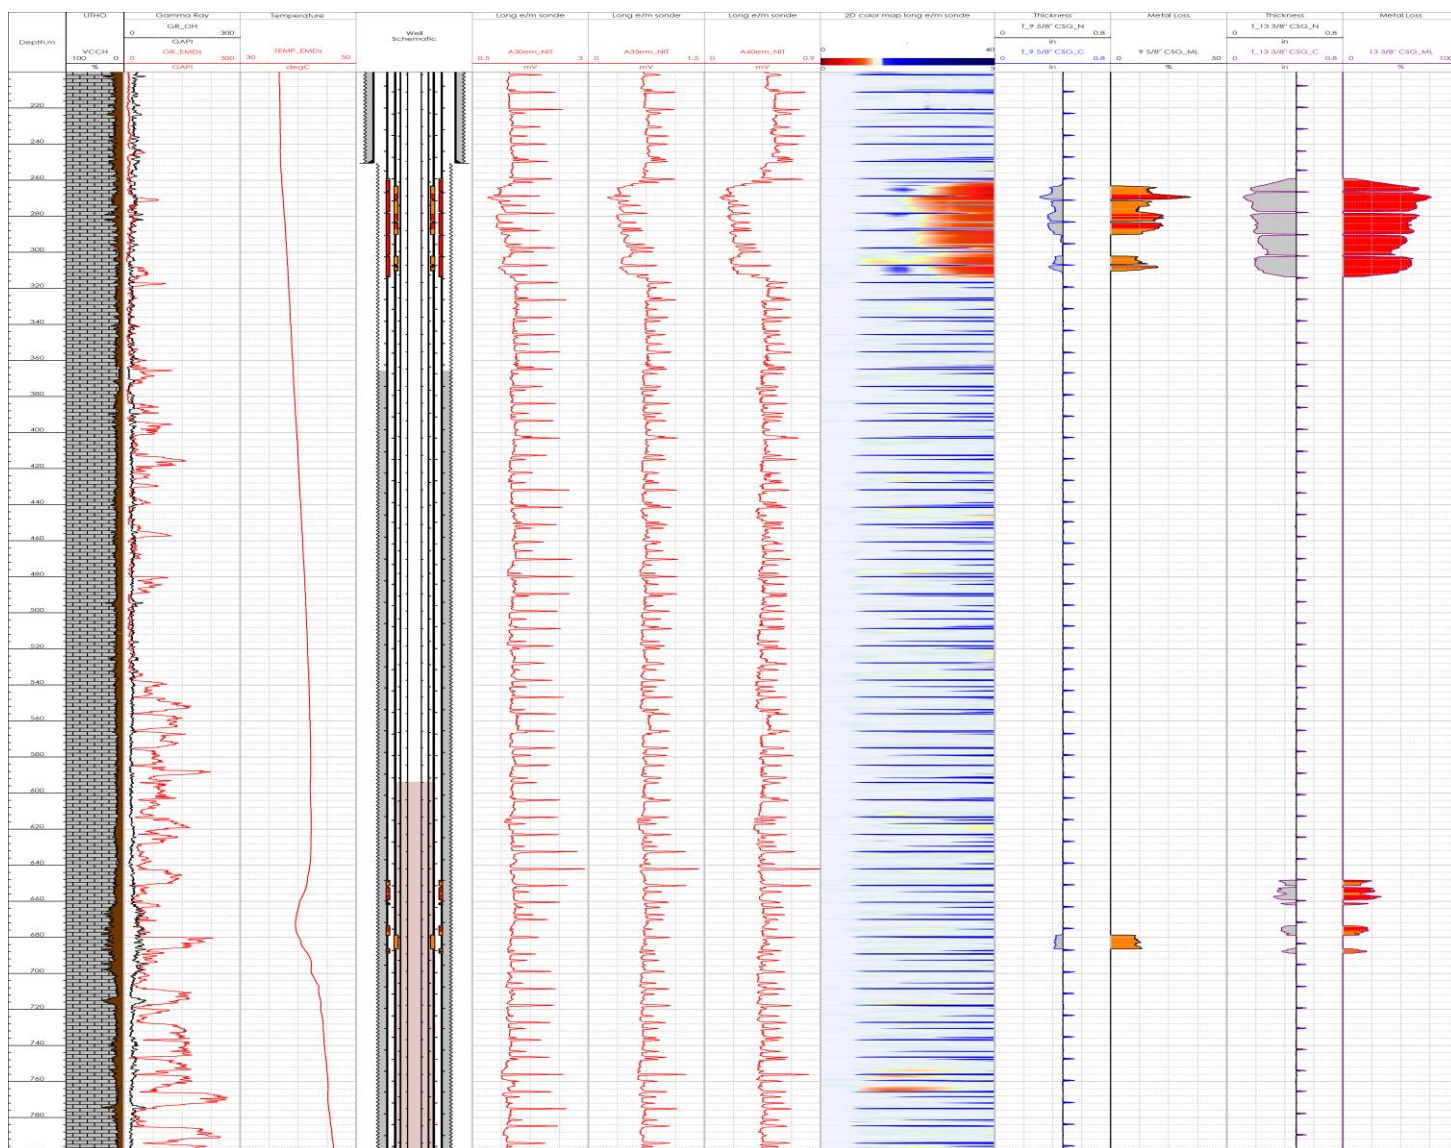
The recorded log data indicated the presence of two corroded intervals in the 13 3/8" casing:

- In the upper section of the well an extended interval of severe metal loss in the 13 3/8" casing below the 18 5/8" conductor with a maximum metal loss of 90%.
- In the middle section of the well there was a maximum metal loss of 30%.

From the EMDs log data the 9 5/8" casing had 2 intervals of metal loss:

- In the upper section of the well with maximum metal loss of 45%. It appeared that corrosion had migrated from the 13 3/8" casing.
- In the middle section of the well with maximum metal loss of 13% which was possibly caused by corrosion migration from the surface casing.

It is likely that the upper interval of corrosion in the 9 5/8" casing was the main root cause of the failed casing pressure test.

In addition, the EMDs gamma ray showed much greater counts in comparison with the open hole gamma ray curve. The shape of the EMDs gamma ray curve indicated scale accumulation on the internal tubing wall across the pipe body.
