Challenge:

One example when acoustic logging was conducted was to identify the root cause of the B annulus leak-off test (LOT) failure, this is shown below:

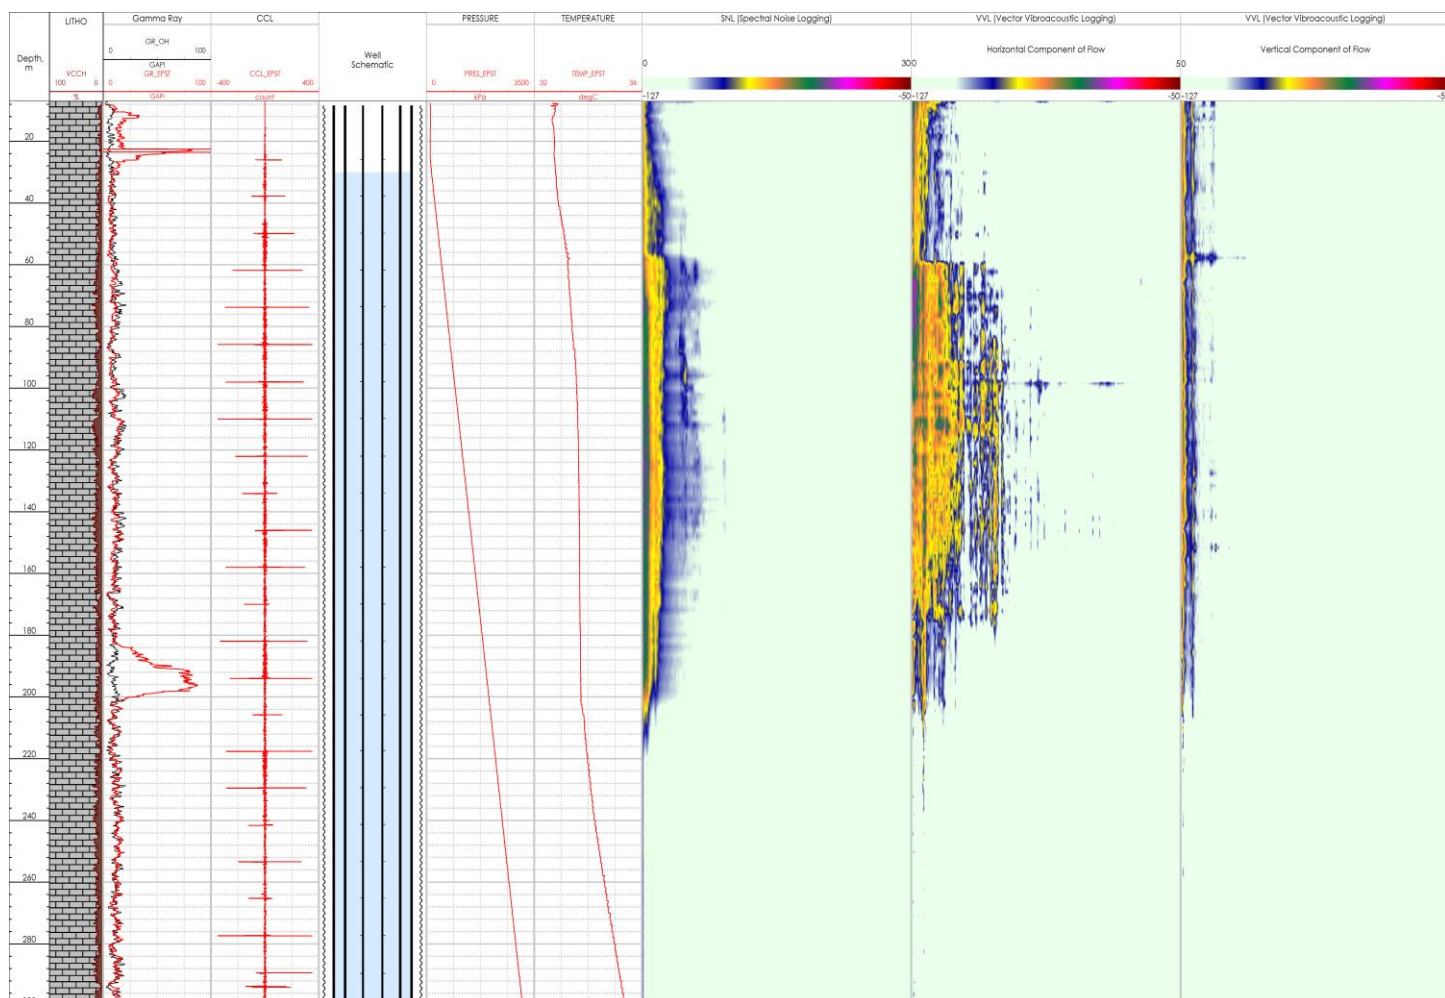
An acoustic logging pass was conducted while pumping water into the A annulus. SNL data showed fluid movement from surface-200 m. VVL data indicated the presence of vertical downward flow movement at an interval from surface-200 m. It was observed that the formation was taking fluid flow horizontally from 56-200 m with a more intense flow at 56-74 m. The temperature curve supported the acoustic log findings as the temperature curve confirmed crossflow at 60-200 m. The gamma ray curve showed significantly greater counts at a depth of 23 m compared to the original open hole log. This could be attributed to scale accumulation (possible depth of leak on the 9 5/8" casing and 13 3/8" casing). Additionally, the gamma ray curve had greater counts from 183-200 m which confirmed the end of the crossflow zone.

The 9 5/8" casing has a through-wall defect at a very shallow section at 23 m. The water pumped into the A annulus passed through the leak in the 9 5/8" casing and into the B annulus. The fluid then entered the formation and travelled to a depth 200 m. The flow across the formation was not even with a different intensity across the interval 56-200 m.
