**Integrity Challenge:**

**High Temperature Logging Results:**

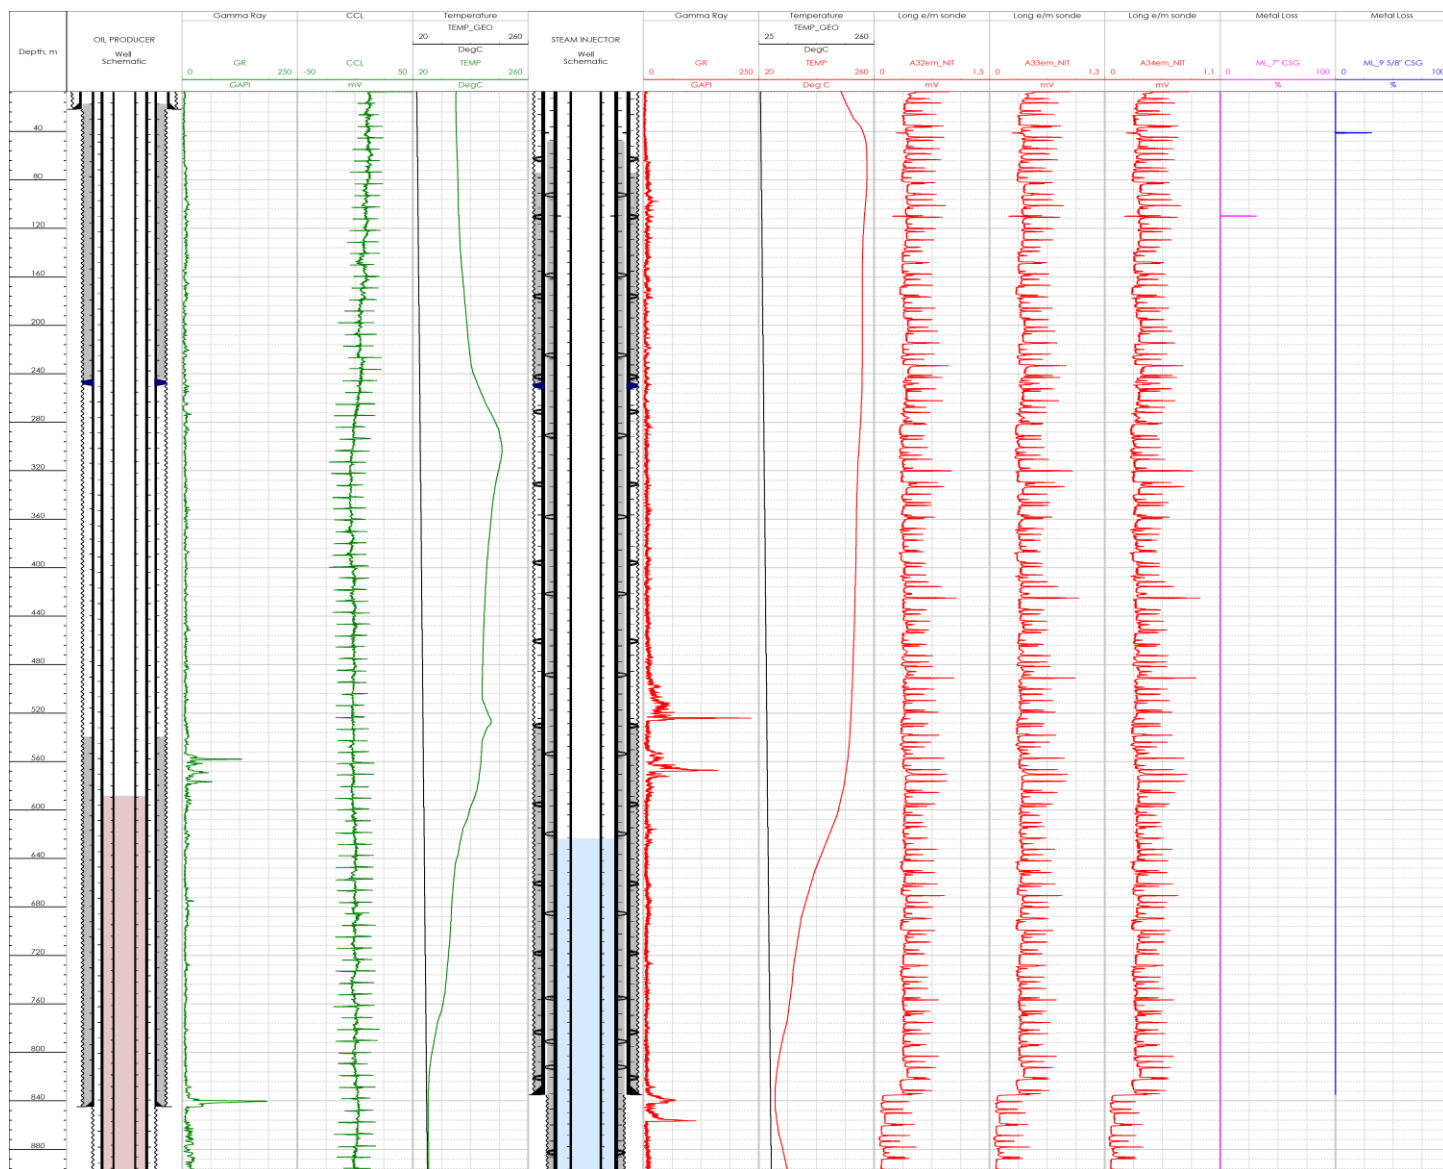
The well is a vertical oil producer drilled in 2016. After drilling the well was completed with 9 5/8" casing, a 7" production casing and a 3.5" progressive cavity pump (PCP) completion. The well was drilled as an infill well in a field with heavy oil and with steam injector wells nearby. In June 2022 after 6 years of production, the average wellhead temperature was approximately 70 degree C, it suddenly increased sharply to 130 deg C. To understand why the temperature had suddenly increased a decision was made to shut the oil producer to cool down Well Head temperature and record temperature profile. The log data indicated that the upper section of the well had heated to a maximum temperature of 205 degree C at a depth of 300 mbdf. The client suspected that there was communication between a nearby steam injector well and the oil producer. To confirm this assumption, the steam injector was closed in and 3 days after the shut-in period a high temperature tool was run in the steam injection well. The log data indicated that the upper section of the well was heated up to a maximum temperature of 260 degree C at a depth of 38 mbdf. The temperature curves indicated a downward crossflow from 41 mbdf to 260 mbdf. The temperature curves, recorded in both wells, indicated that there was a steam breakthrough at the upper section of the production well. To understand the steam injector well integrity failure, it was decided to run a corrosion log in this well. The well was cooled down and corrosion data was recorded from the surface to 900 mbdf. The EMDs data indicated the presence of a localized defect in the 7" casing at a depth of 110 mbdf, below a casing coupling. In addition, a localized defect was identified in the 9 5/8" casing at 41 mbdf. However, it should be noted that there were no indications of any defects in the completion string. Based on the temperature and corrosion data, the steam injector was worked over. During the workover it was identified that a pup joint in the completion string located below the tubing hanger had been insufficiently torqued. This in all probability would have been the entry point for the steam in the A annulus. Additionally, the steam had moved from 110 mbdf (defect in the 7" casing) upwards to 41 mbdf and entered the formation across the defect in the 9 5/8" casing. The client decided to install a patch to cover the defect in the 7" casing to avoid steam flow into the formation.

Cyclic steam injection will result in expansion and contraction of the tubing and casing strings which puts additional stresses on connections which have not been made up properly which could result in leak paths. Possible solutions include correct make up torques, expansion collars in casing to reduce wellhead growth and seal bore extensions in tubing to accommodate tubing movement.
