**Integrity Challenge:**

**Corrosion Logging Result:**

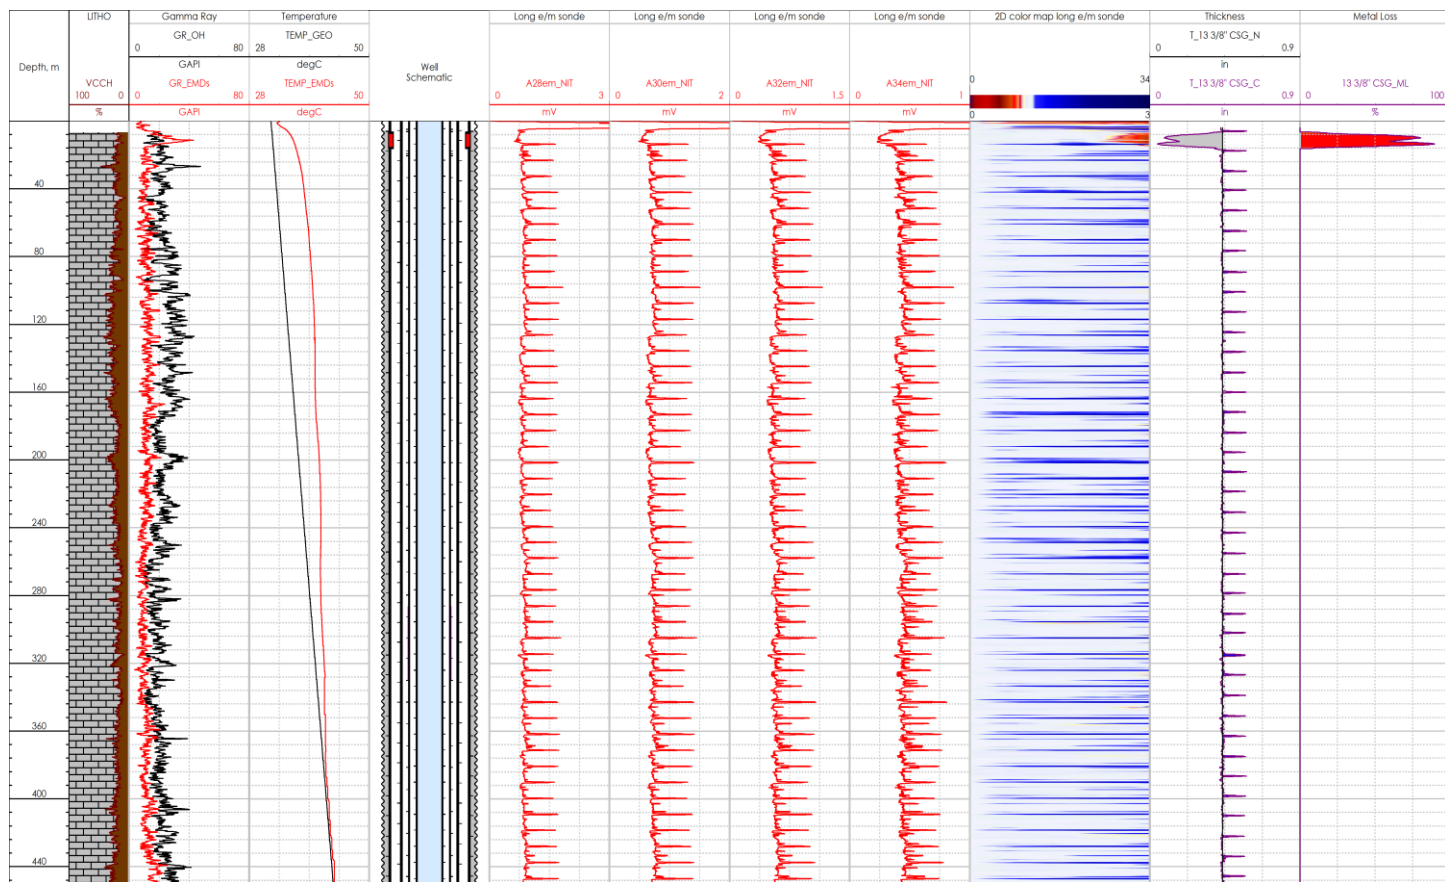
One example when corrosion logging was done in a 4 barrier well (strings) and metal loss on the outer casing was detected is shown below: The well is a vertical water injector drilled more than 40 years ago. After drilling the well was completed with 13 3/8" surface casing to 813 m, the 9 5/8" intermediate casing with the shoe at 1407 m and the 7" liner from 1252-1511 m. A 4.5" completion string was run in hole to 1400 m. In 2016 a Hoist was mobilized to location and the completion string was pulled. The 9 5/8" casing was successfully pressure tested and a 7" scab liner was run in hole from surface to the top of production liner. A 4.5" completion string was run in hole to 1435 m.

In 2019 a subsurface integrity test (SIT) was conducted and the C annulus failed the leak off test (LOT). In 2022 EMDs corrosion logging was conducted. Data from the logging revealed severe metal loss in the 13 3/8" surface casing at a shallow section of the well. This is probably the main cause of the C annulus LOT failure. From the data the Operator could then re-evaluate their C annulus management program e.g., reduce the maximum allowable surface annulus pressure (MAASP), increase annulus pressure monitoring and increase blow-down frequency if required. This may also result in a requirement to conduct more frequent corrosion logging to establish metal loss increase over time.

Drilling across a loss zone leads to a high probability of poor cement quality and free pipe. If there is a corrosive aquifer, the possibility of external corrosion is increased drastically. It is critical to understand the integrity of the pipe across these areas. Regular logging is recommended to identify when corrosion will migrate from the outer pipe to the inner pipe. This will enable a remedial program such as installing a scab liner to be instigated before a catastrophic failure.
