Integrity Challenge:

Corrosion Logging Result:

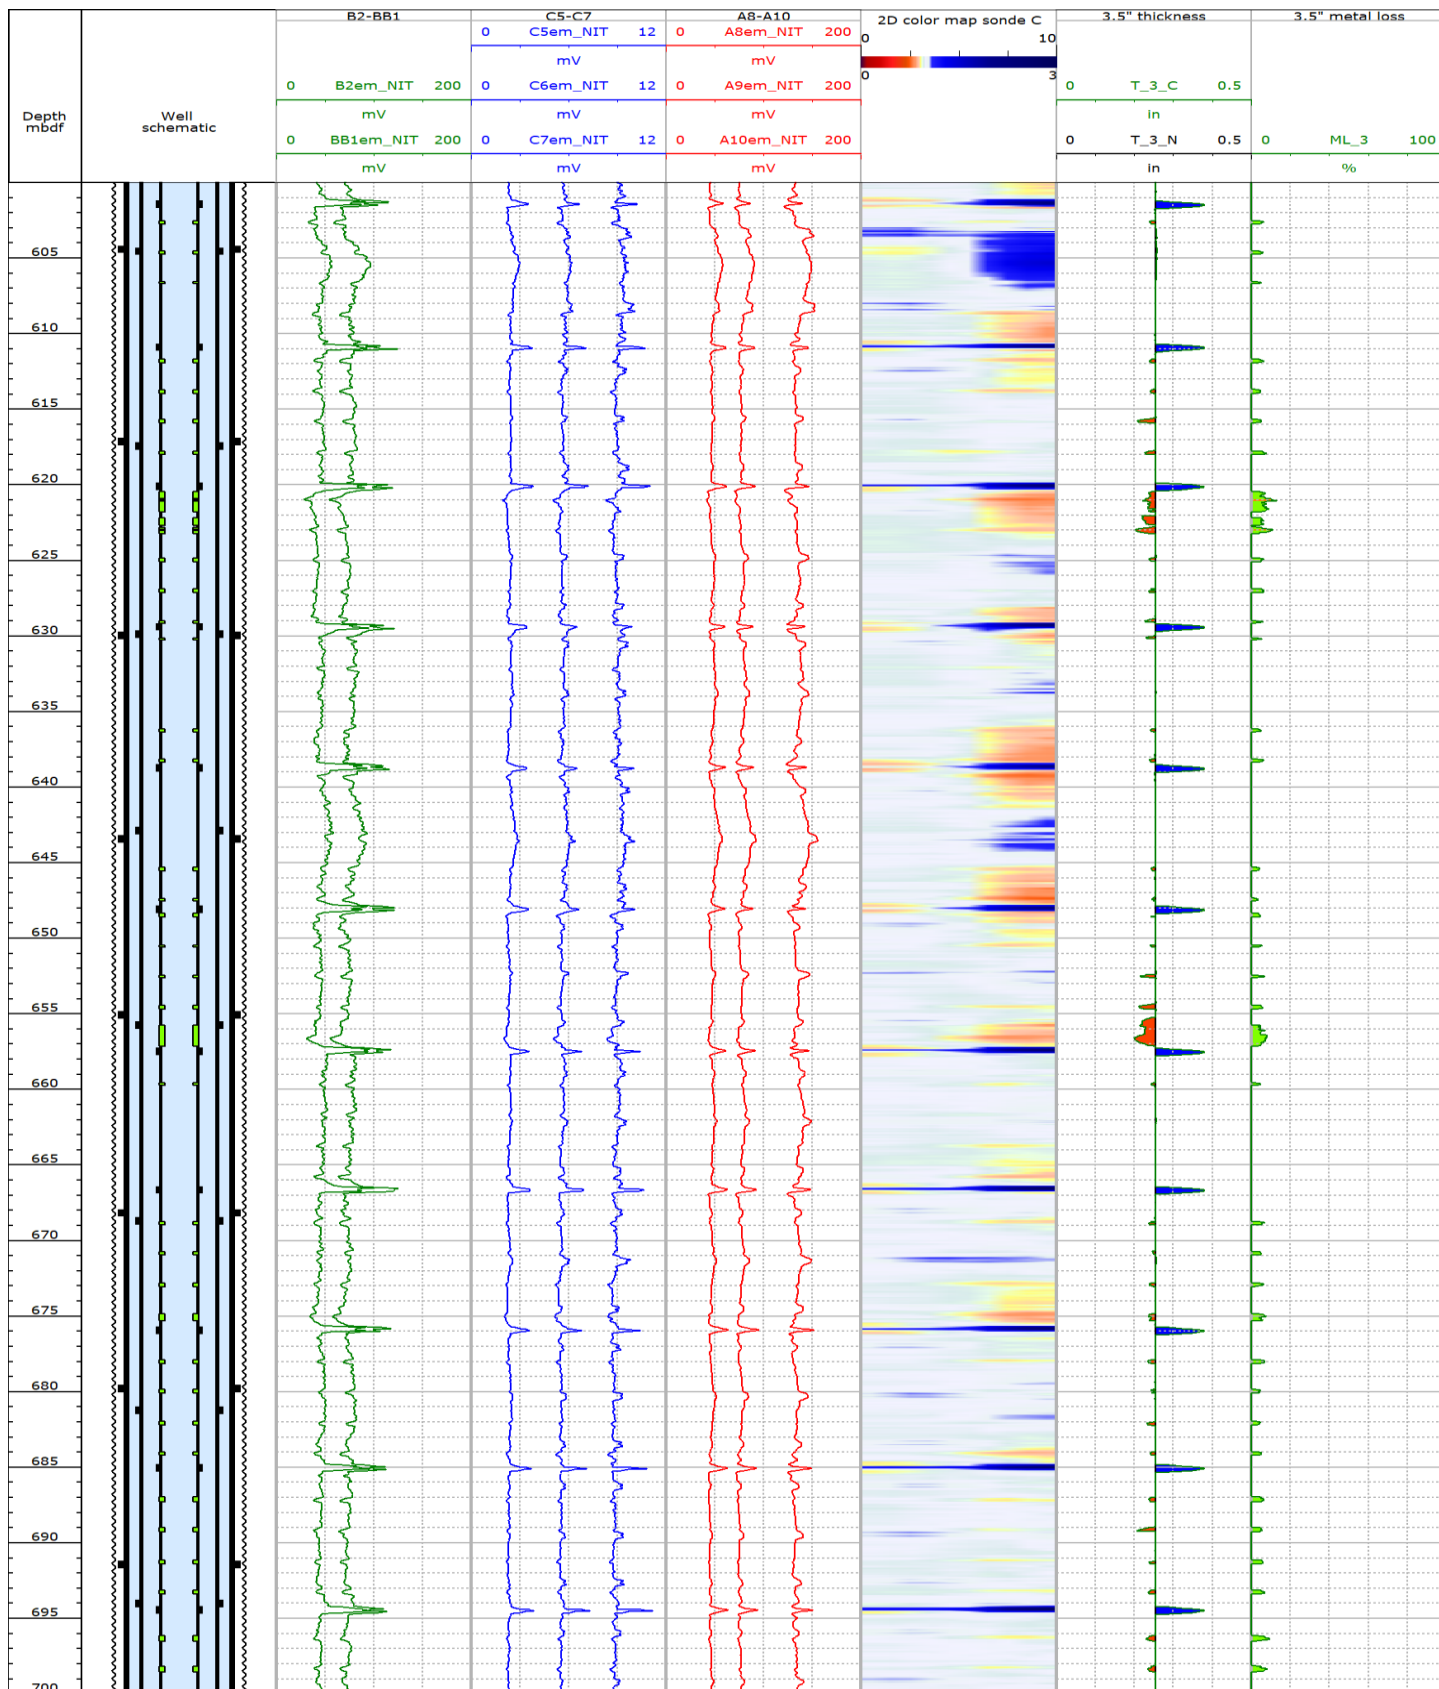
The EMDs log data revealed the presence of numerous wear areas on the tubing caused by buckling of the SR assembly against the internal tubing wall during the SR rotation. Defects were caused by the SR couplings and centralizers. The circumferential calculated metal loss ranged from 5.0-13.4%. Minor corrosion was also identified in the areas of wear.

EMDs Data with Calculated Thickness and Metal Loss.

The EMDs data showed an average circumferential metal loss whereas the MFC showed the exact metal loss. The difference observed between the logging tools reached up to 30% across some areas.

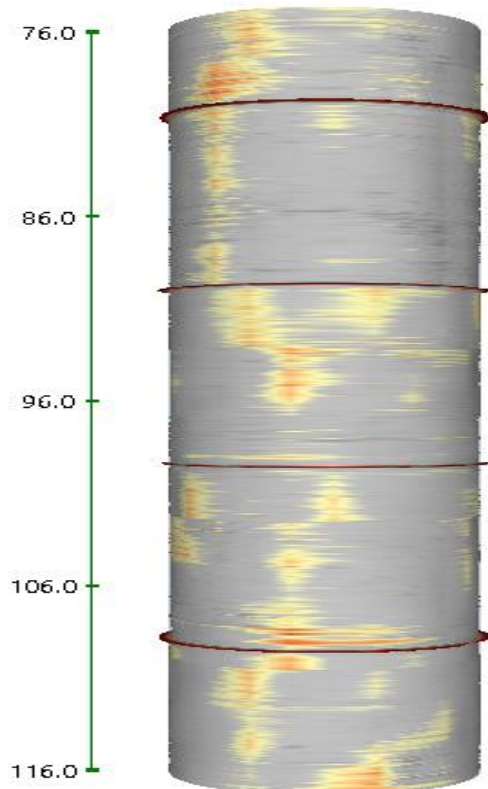
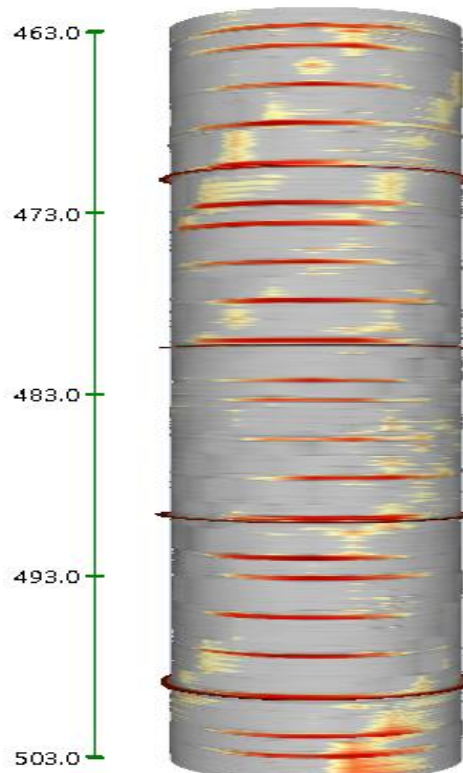
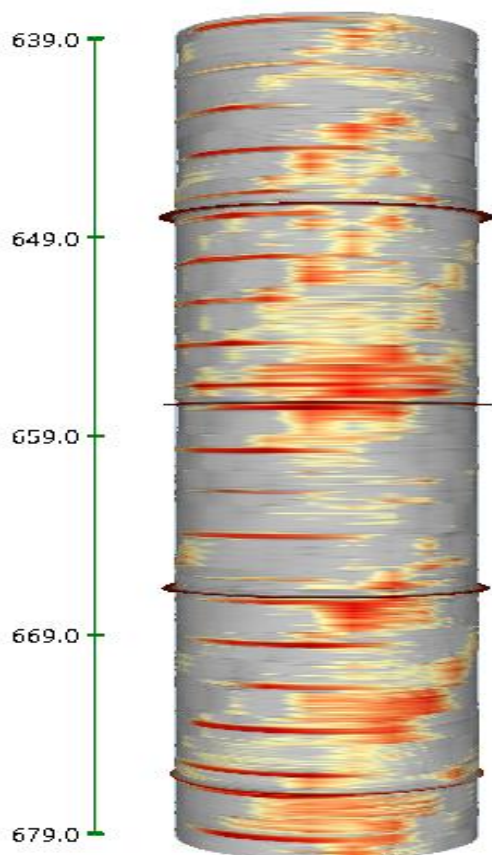
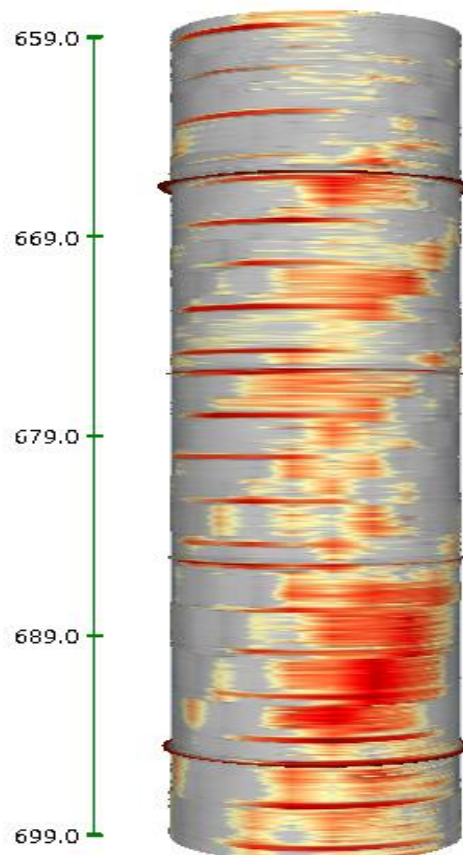
- The tubing from surface-208 m (vertical section) had light general corrosion with maximum metal loss from 5-9%.
- Erosion caused by the SR coupling. The tubing from 208-344 m (vertical section) had areas of wear caused by the contact of the SR coupling against the tubing internal wall due to additional side forces. The areas of wear were detected every 9 m which is the length of the SR joint. The wear areas matched the coupling size, width 7cm and height 2 cm. Maximum metal loss from 17-20%.

- Erosion caused by the SR centralizers. The tubing across the S-shape section of the well (345-700 m) had numerous wear areas caused by the SR centralizers contacting the internal tubing wall during SR rotation. The size of the wear areas corresponded to the centralizer dimensions, width 7 cm and height 3 cm. It was possible to verify the actual dimensions of the centralizers as there were SR assemblies available on location. Maximum metal loss was from 40-43% identified at 377.4 m, 379.1 m and 623 m.

- Combination of SR body and centralizers erosion. From 582-700 m in addition to erosion caused by the centralizers, the additional forces due to the deviation in the lower part of the well bows the sucker rod to an extent that the sucker rod body contacts the internal tubing. This causes additional friction and metal wear.

Scenarios of wear areas and metal loss across logged interval in PCP well

Further logging data and analysis can assist in determining an optimized centralization program.
