Integrity Challenge:

Corrosion Logging Result:

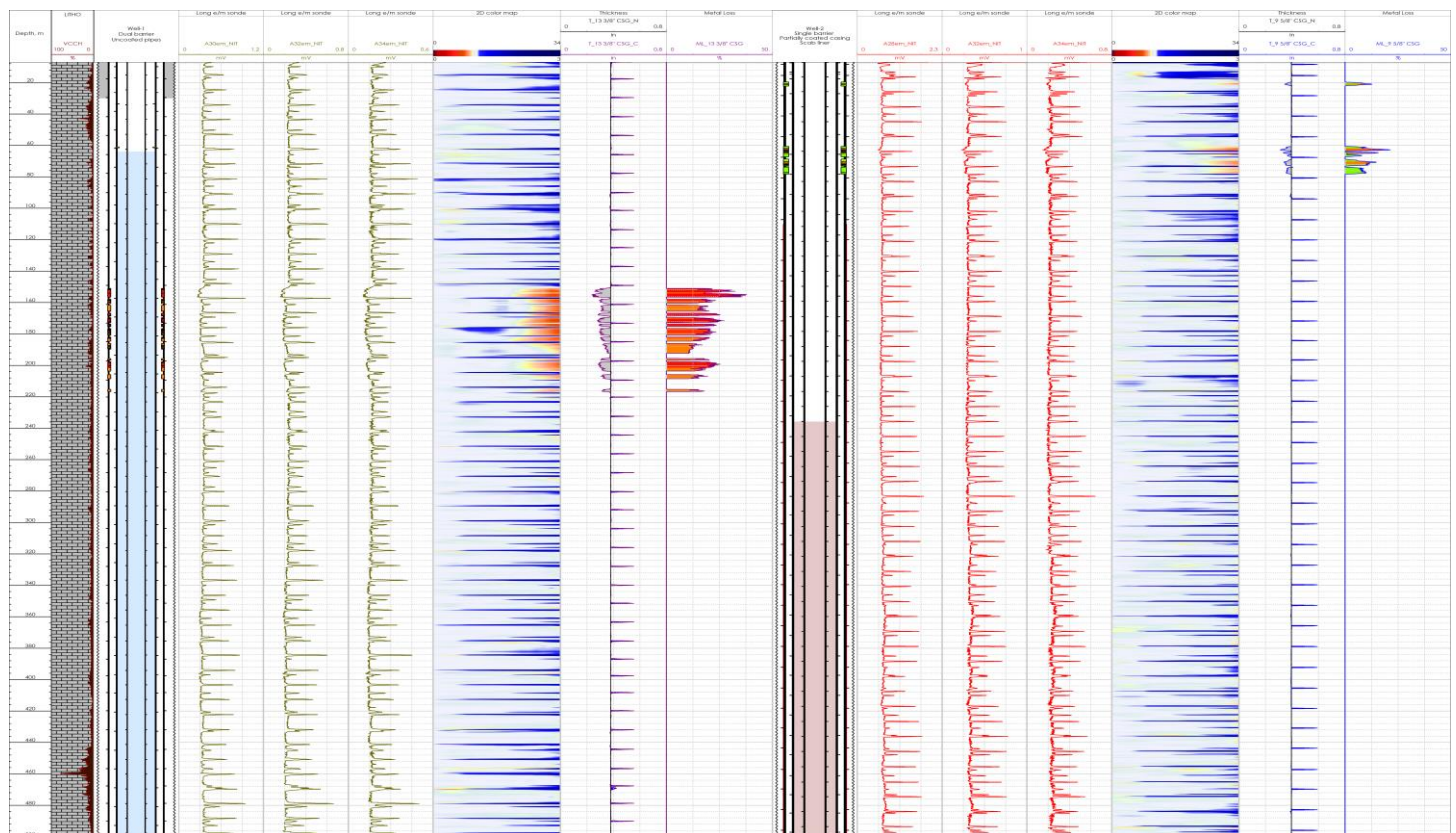
One example of a less than optimal external coating design on the outer casing in one field is shown below: External coating on casing was introduced to the oil industry in the beginning of 2000. Therefore, all wells which were drilled before this will have no external coating. Most of the wells were completed with dual barriers across the upper section due to total losses during the drilling phase and poor cement quality. Corrosion logging was conducted in a number of wells with this completion design in 2012-2013. The log data indicated that most of the wells had corrosion on the outer casing across an interval of 150-230 m. As a result of the logging data the client changed the completion design to a single barrier across the upper section. The outer casing was externally coated from 100 m to the casing shoe therefore protecting the casing from corrosion across the more aggressive corrosive zones. After 5-6 years from the completion date a number of wells were logged as part of a corrosion monitoring program and to check the efficiency of the external coating. The log data showed the following results: almost 80% of the logged wells had corrosion above the coated pipes at an interval of 20-80 m i.e., 20-30 m above the coated the area. It was evident that due to the potential difference between the coated and uncoated areas, corrosion had migrated from 150-80 m and was now concentrated over the smaller uncoated interval which would significantly increase the rate of corrosion in this area. This decreased the lives of the wells drastically as the casing pressure test in some wells failed after 5 years and scab liners had to be installed.
