Integrity Challenge:

Corrosion Logging Result:

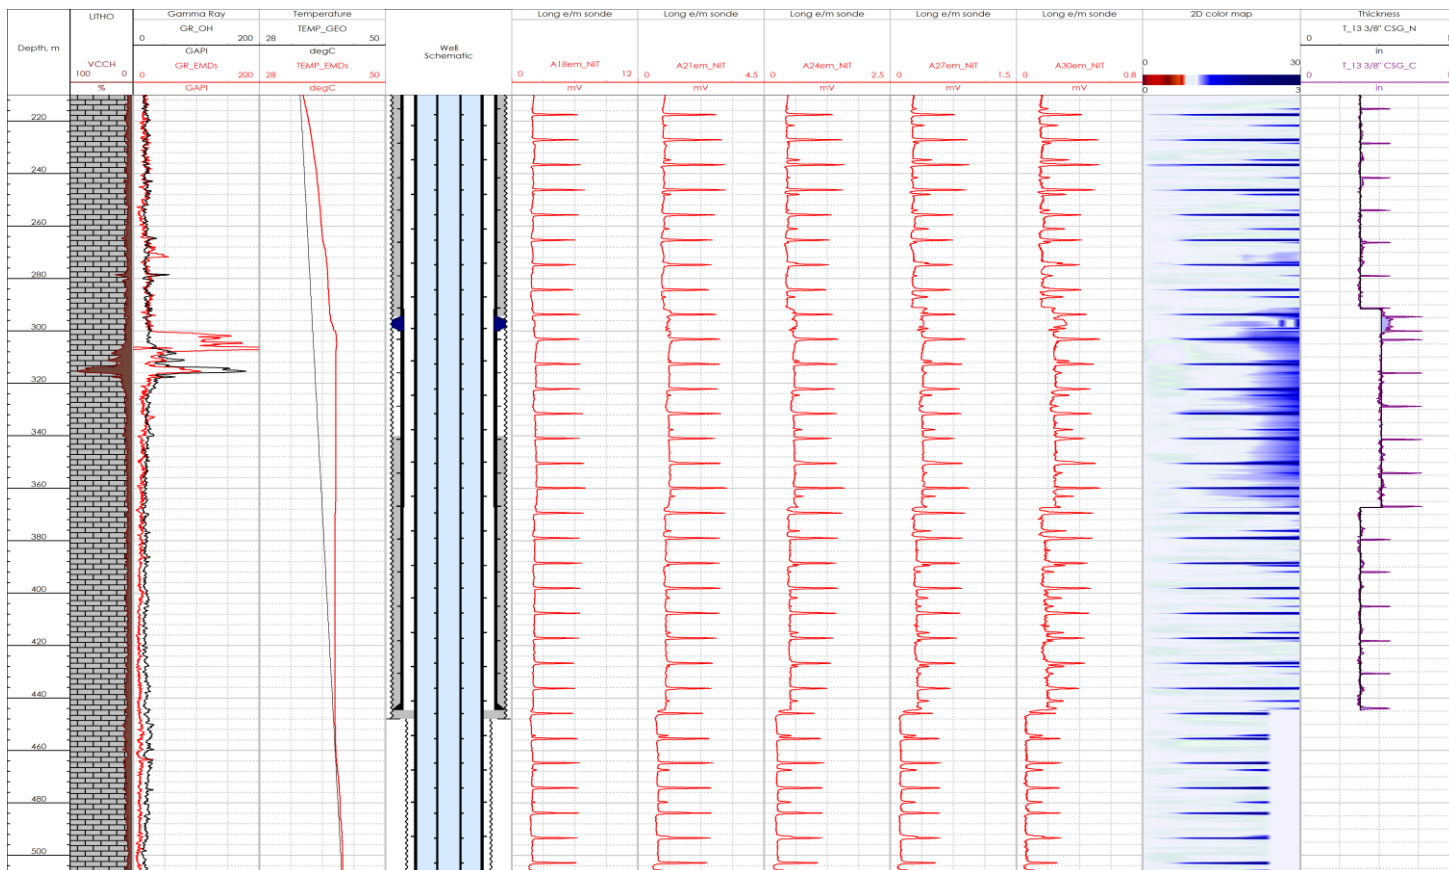
The first EMDs corrosion log was done in 2013 and a repeat log run 2021. Both logs did not reveal noticeable metal loss on the pipes. Corrosion log data identified all completion accessories including surface casing shoe at 444 m. The data shows that the surface casing had joints with different weights: 5 joints at an interval 368-303 m had a greater amplitude which relates to a greater nominal wall thickness. In addition, the heavy weight joint installed below the MSIPC was identified. The temperature curve indicated upward crossflow from the 13 3/8" casing shoe to the top of the MISPC. The gamma ray curve indirectly confirmed crossflow since high gamma ray counts were recorded at an interval below the packer which may correspond to the end of the crossflow.

The log data confirmed that the completion design for this well is suitable for the well conditions and therefore will protect the well from failure due to corrosion.
