Corrosion Logging Result:

The well is a vertical gas lift oil producer drilled more than 20 years ago. After drilling the well was completed with a 9 5/8" surface casing to 952 m, and 7" production casing with the shoe at 2909 m. The 3.5" completion string was run in hole to 2768 m.

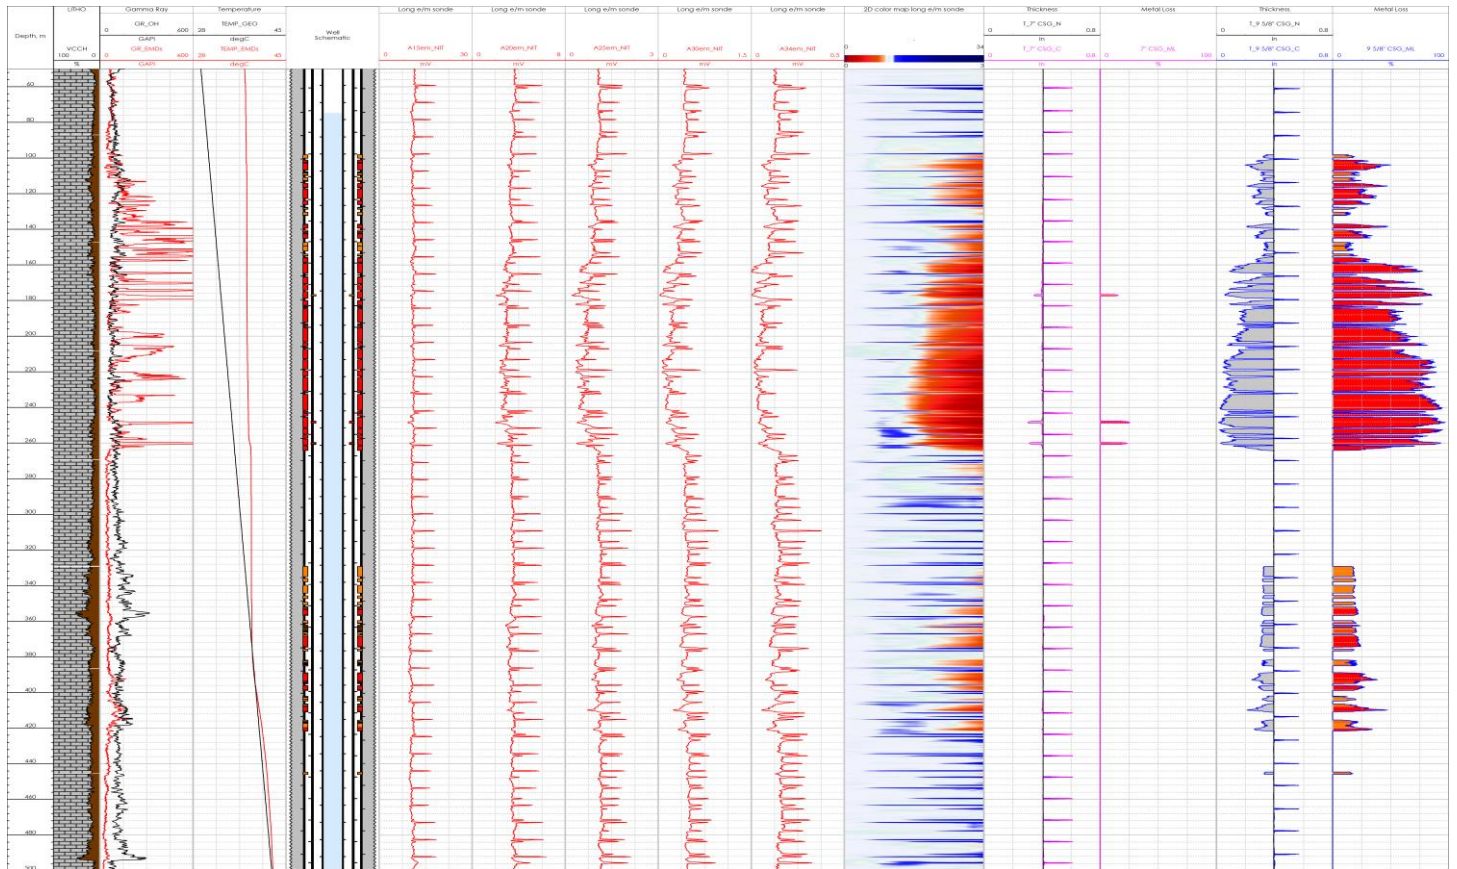
One example when corrosion logging was done in a 3 barrier well (strings) and metal loss on both the casing strings were detected as shown below:

In 2022 a subsurface integrity test (SIT) was conducted, both the A and B annulus failed the leak off tests (LOTs). In addition, communication was observed between the A and B annulus.

After the SIT a decision was taken by the client to run a corrosion log to verify the LOT failure. The logging operation was standalone and the tool was run through the completion. The EMDs log data revealed the presence of two extended intervals of severe corrosion in the 9 5/8" surface casing at the shallow section of the well. In some areas the metal loss was almost 100%. In addition, high gamma ray was recorded across the upper corroded interval indicating probable scale accumulation. Also a few localized intervals of corrosion in the 7" casing were detected. This is probably the main cause of the A to B annulus communication.

The well was then suspended in line with the company integrity guidelines pending remedial action to safely secure the well.
