Integrity Challenge:

Corrosion Logging Result:

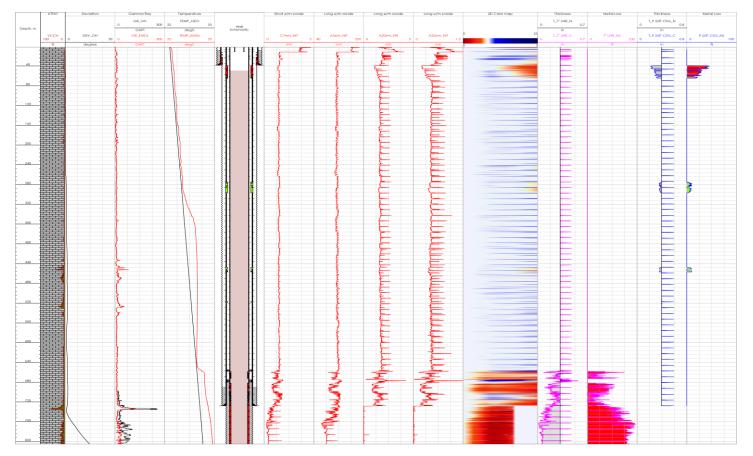
One example when corrosion logging was done under Hoist operations is shown below:

The EMDs data indicated the presence of severe metal loss in the 13 3/8" conductor. There was an extended interval of severe corrosion in the 9 5/8" casing below the bottom of the conductor. Maximum metal loss was almost 50%. In addition, an extended interval of severe corrosion was detected in the 7" liner from the bottom of the logging interval at 805 m to the 7" liner hanger at 675 m. Maximum metal loss was identified at the bottom of the logging interval which was almost 100%. Furthermore, the EMDs tool captured severe metal loss in the lower part of the 7" scab liner with maximum metal loss of 70%. It appeared that corrosion from the liner had migrated upwards to the scab liner. Taking into consideration the EMDs data, there is high possibility that the scraper run hold up and unsuccessful milling occurred due to a collapse in the highly corroded 7" liner.

The example above shows that real time corrosion logging during critical operations such as a workover can provide integrity data of the well. This allows the workover program to be adjusted and eliminate unnecessary attempts to set a packer and will result in reduced Hoist operational time and ultimately saving significant costs.
