Field Overview:

EMDs Overview:

Metal Loss Analysis:

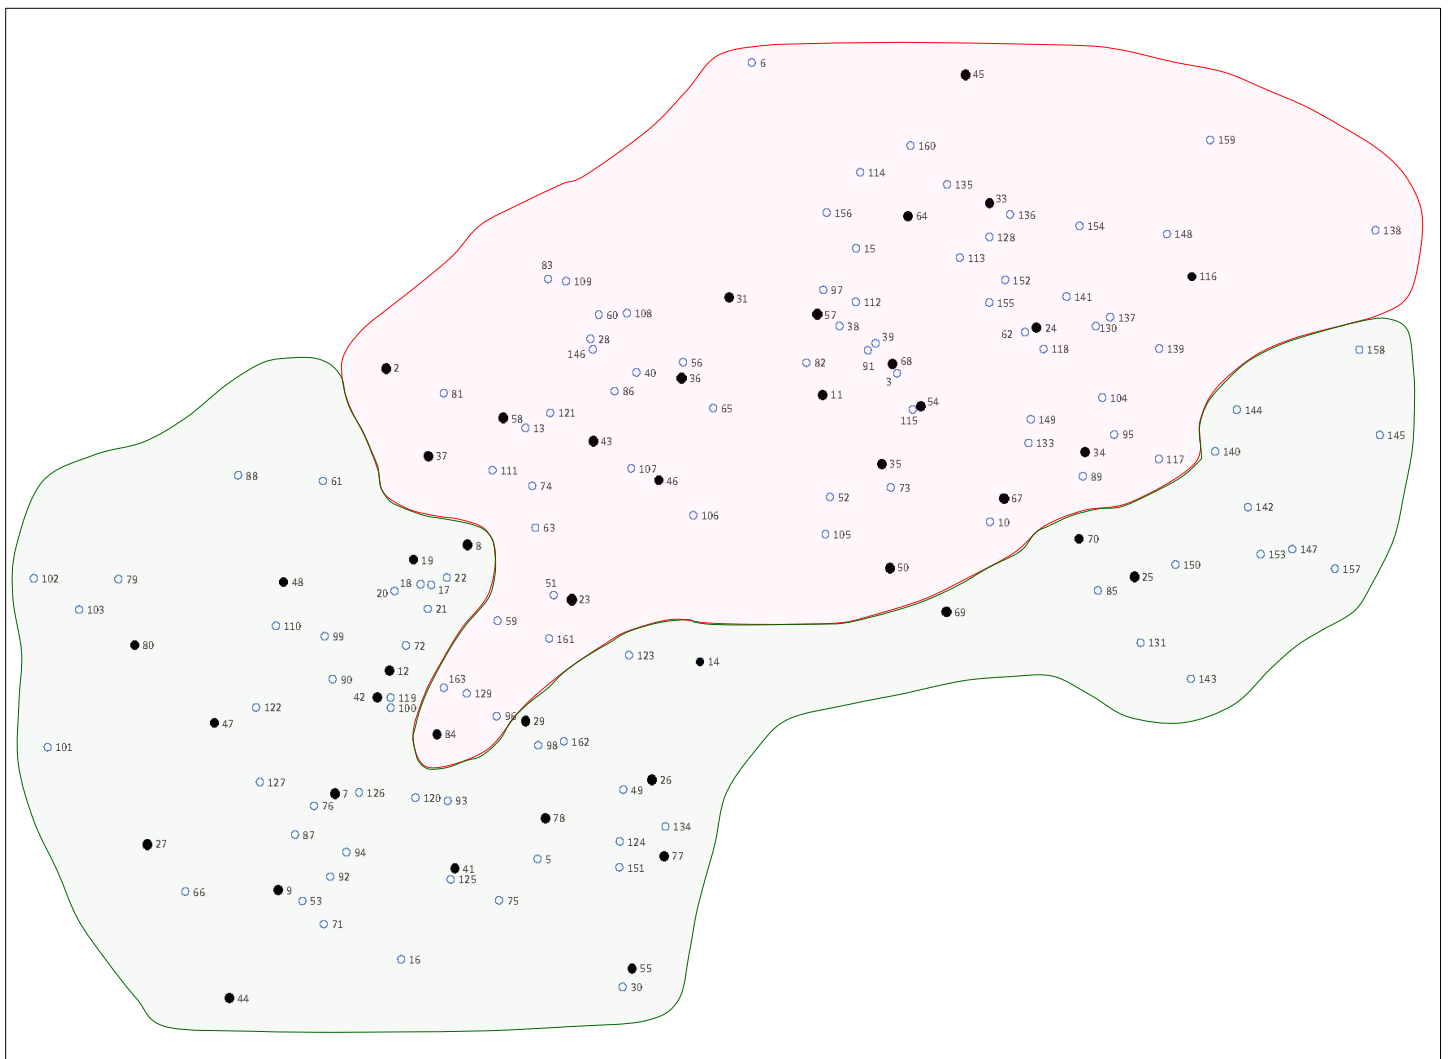
The first observation from the log data was related to the gamma ray and temperature logs. The logged wells can be divided into two groups based on temperature and gamma ray behavior.

Group B The temperature curve had no indication of crossflow and showed a standard temperature gradient across the upper section of the well. The gamma ray also had no abnormal values.

The map below shows all the wells drilled and the two groups of wells:
