**Integrity Challenge:**

**Corrosion Logging Result:**

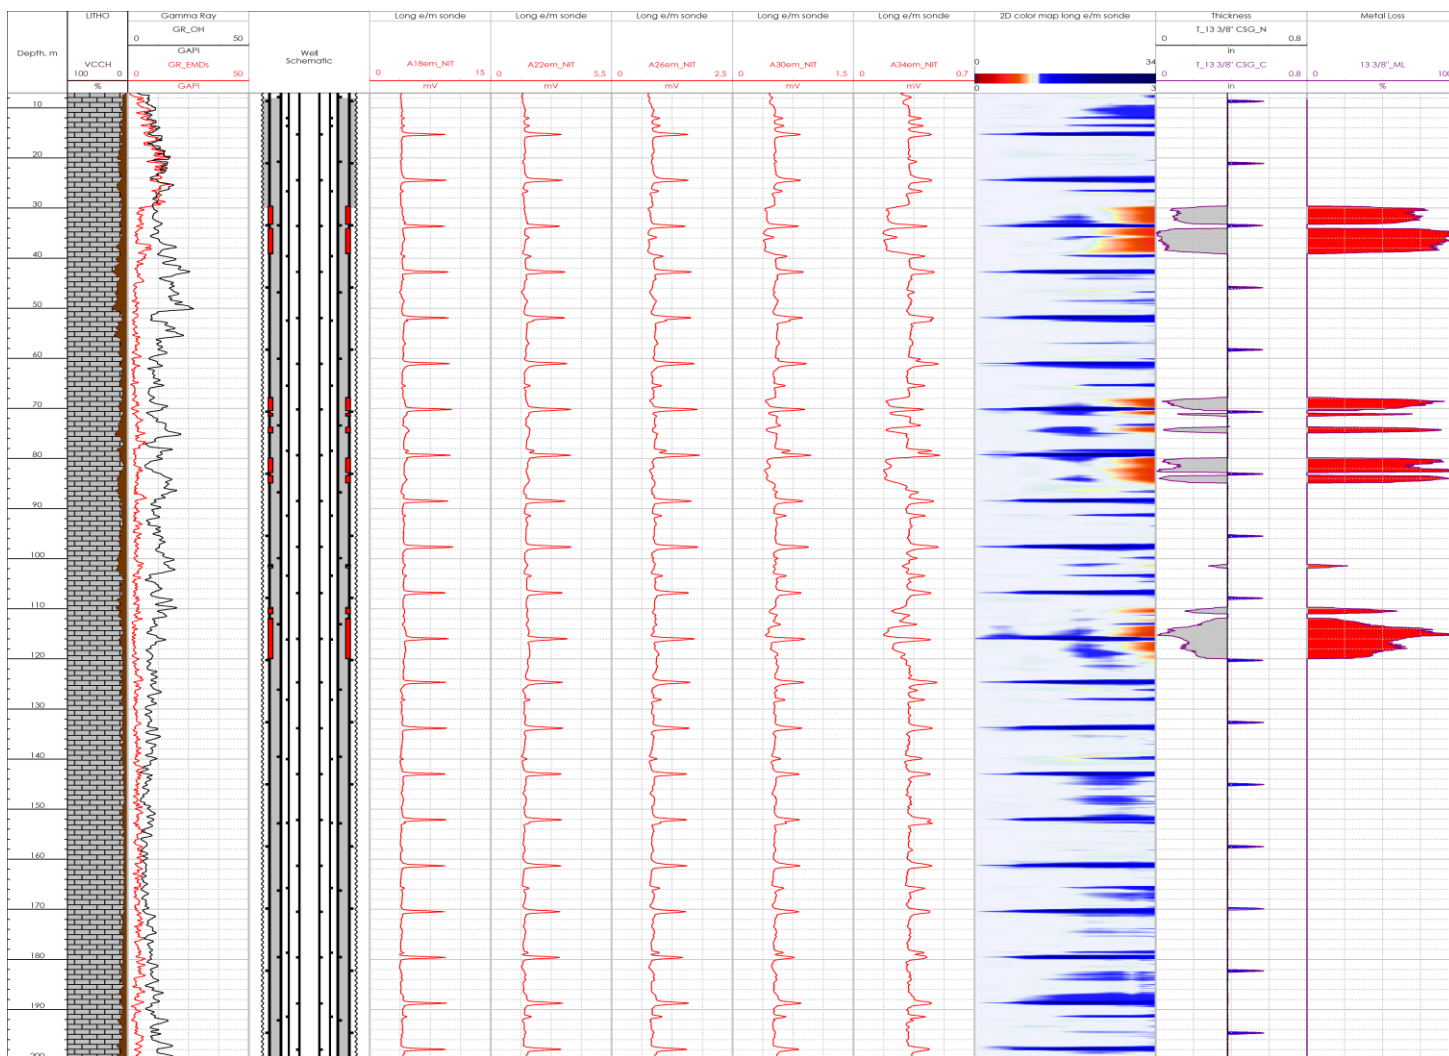
One example when corrosion logging was run in a 4 barrier well (strings) and metal loss on the outer casing was detected is shown below: The well is a vertical oil producer drilled in 1989. The well was completed with a 13 3/8" surface casing, a 9 5/8" intermediate casing, and a tapered 7 5/8" x 6 5/8" gravel pack (GP) and wire wrapped screens (WWS) extension which was run across the open hole section. A 3.5" beam pump (BP) completion string was run. In 2017 a Hoist attended the well. The completion string was pulled. The 9 5/8" casing was successfully pressure tested. However, as a proactive measure a 7" scab liner was installed. A 4.5" BP completion was run. In 2021 a Hoist attended the well due to a pump failure. The completion string was pulled. To further minimize sand production which had caused the pump to fail an additional 4.5" WWS was installed across the original 7 5/8" x 6 5/8" GP and WWS. A 3.5" BP completion was run. In 2022 EMDs corrosion logging was conducted. The log data indicated multiple intervals of severe metal loss in the 13 3/8" casing at the shallow section of the well. There was no corrosion evident in the 9 5/8" casing. The maximum metal loss in the 13 3/8" casing was almost 100%. The well had two effective barriers in the upper section of the well i.e., the 7" scab liner and the 9 5/8" intermediate casing. It is therefore recommended to monitor the well on a regular basis to identify if the corrosion in the 13 3/8" casing is migrating to the inner strings. The data will also be used to calculate the annual corrosion rate.

Drilling through a loss zone leads to a high probability of poor cement quality and free pipe. If there is a corrosive aquifer, the possibility of external corrosion is increased drastically. It is critical to understand the integrity of the pipe across these areas. Regular logging is recommended to identify when corrosion will migrate from the outer to the inner pipes. This will enable a remedial program such as installing a scab liner to be planned before a catastrophic failure.
